First reduce the pressure, then restore – the journey towards active seagrass restoration in Berre lagoon

Dr MAYOT Nicolas, DULEY Julie, GRISEL Raphaël

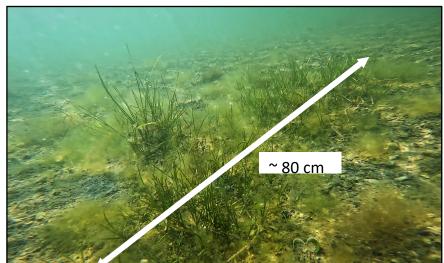
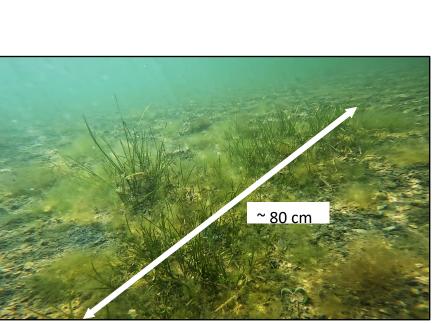
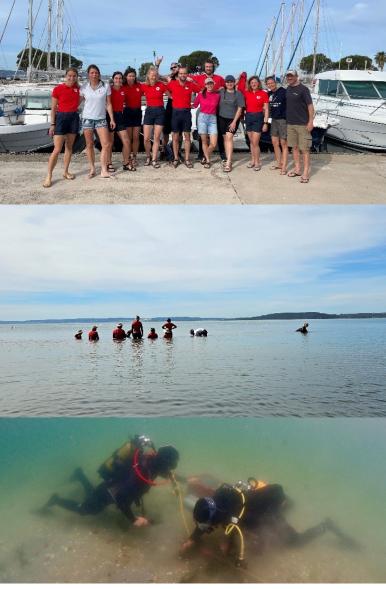
- Mean growth at T+4 months: 88cm and 41cm at the 2 sites
- Surviving rate at T+2 months: 96% and 70% at the 2 sites
- Increase in juvenile fish biodiversity

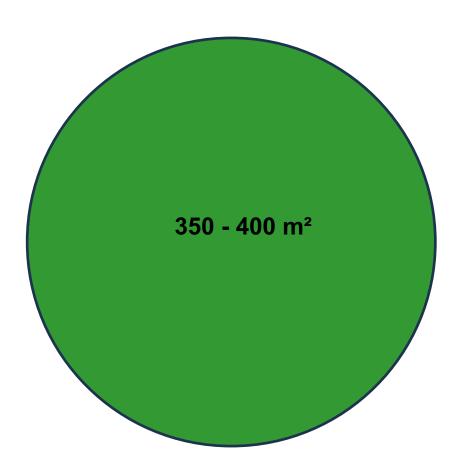
Surface area growth from restoration pilot?

❖ Surface growth : ~ x50 in 4 months

7,8 m² 4 months
